UPPER RESERVOIR DAM

NH 00049

PHASE I INSPECTION REPORT NATIONAL DAM INSPECTION PROGRAM

Date of Inspection: October 26, 1979

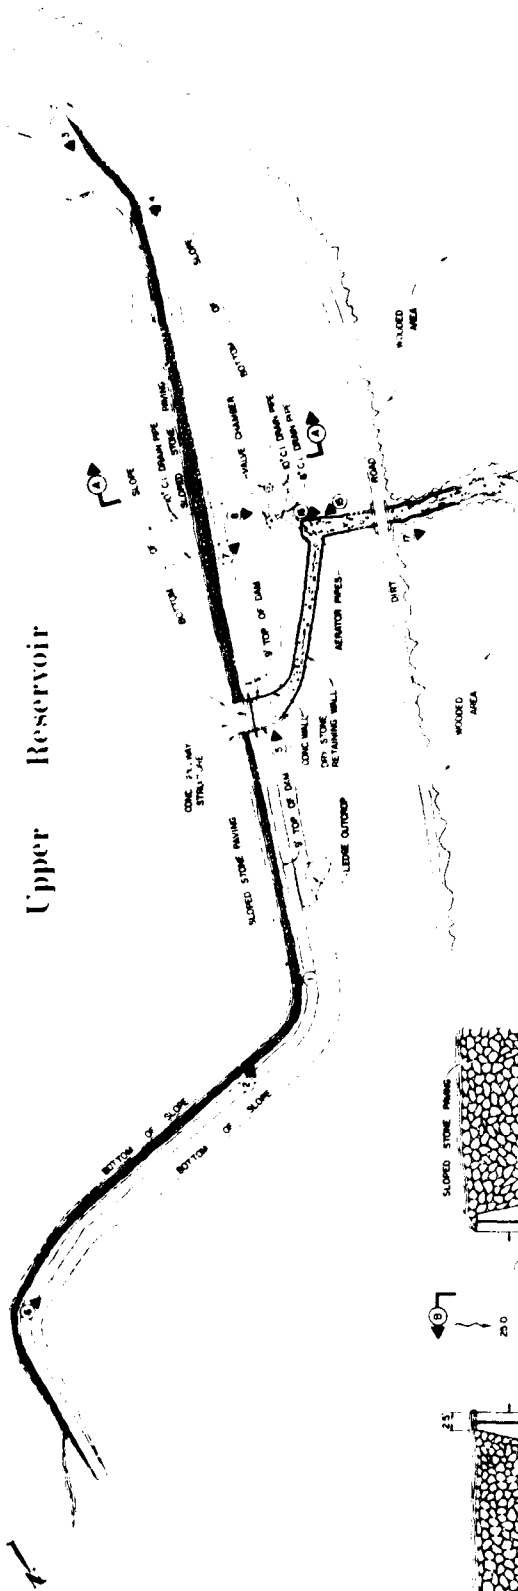
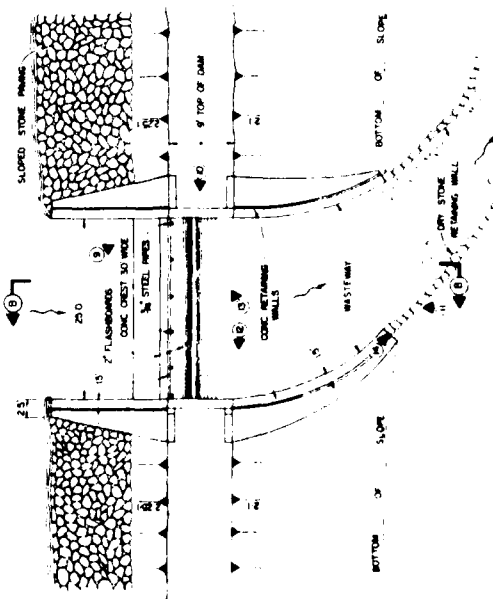
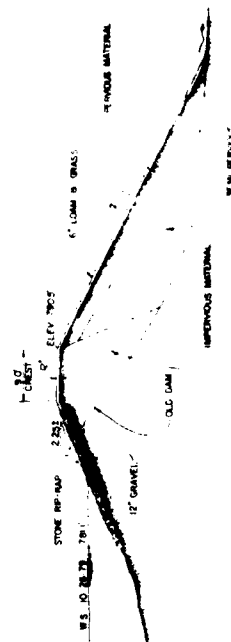
Figure 1 of 2

The pond is drained by a 10 inch pipes as shown in Figure 1. The pipes are controlled by valve located in control chamber. The pipe and control appeared to be in good condition.
